BUREAU OF SHIPS GROUP

TECHNICAL INSPECTION REPORT

USS NEVADA (BB36)

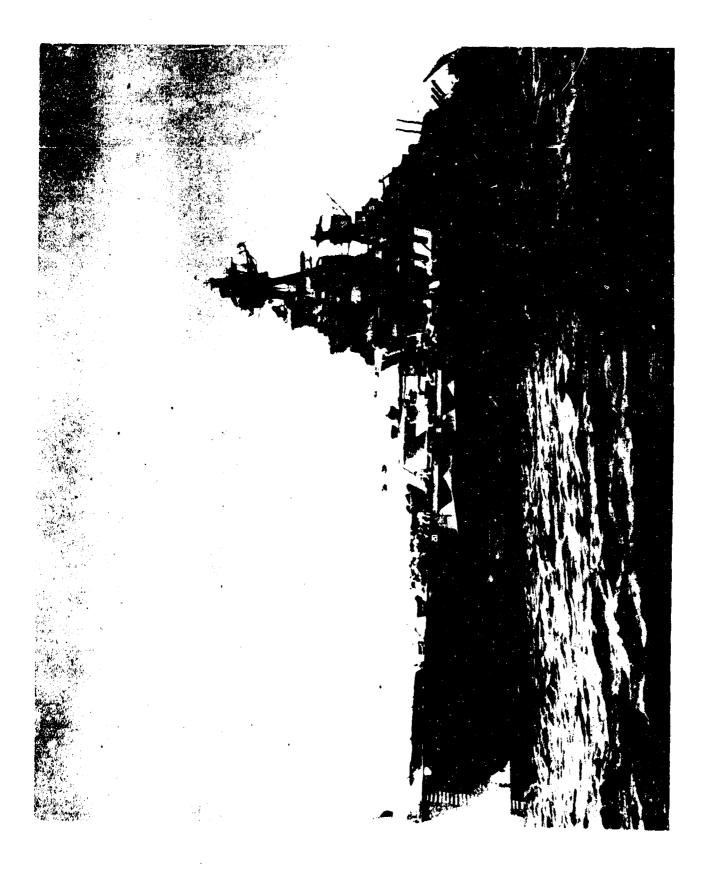
AA-CR-227-91-75. View from off port bow after Test A.

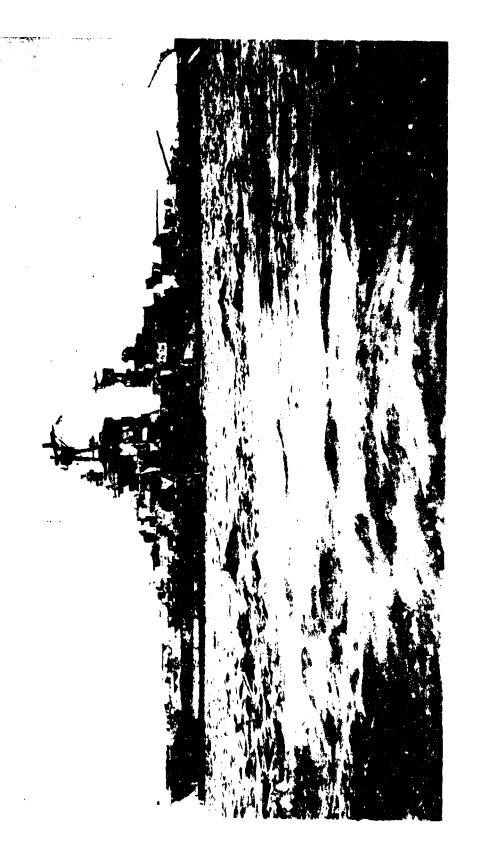
AA-CR-227-91-74. View from off port beam after Test A.

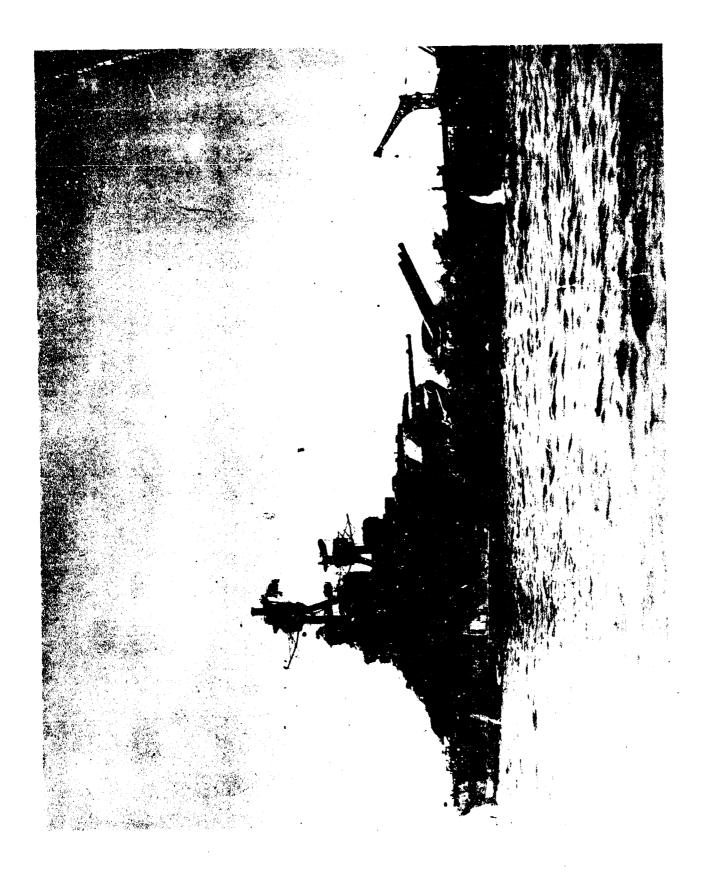
AA-CR-227-91-73. View from off port quarter after Test A.

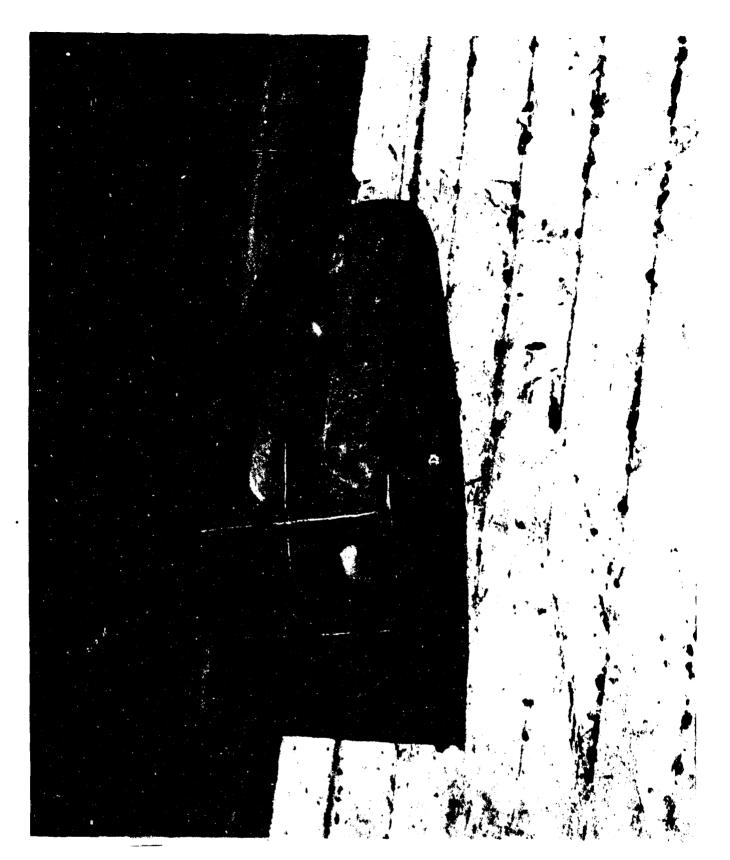
AA-CR-80-1909-12. Part of radar antennae at frame 42, starboard side on the upper deck.

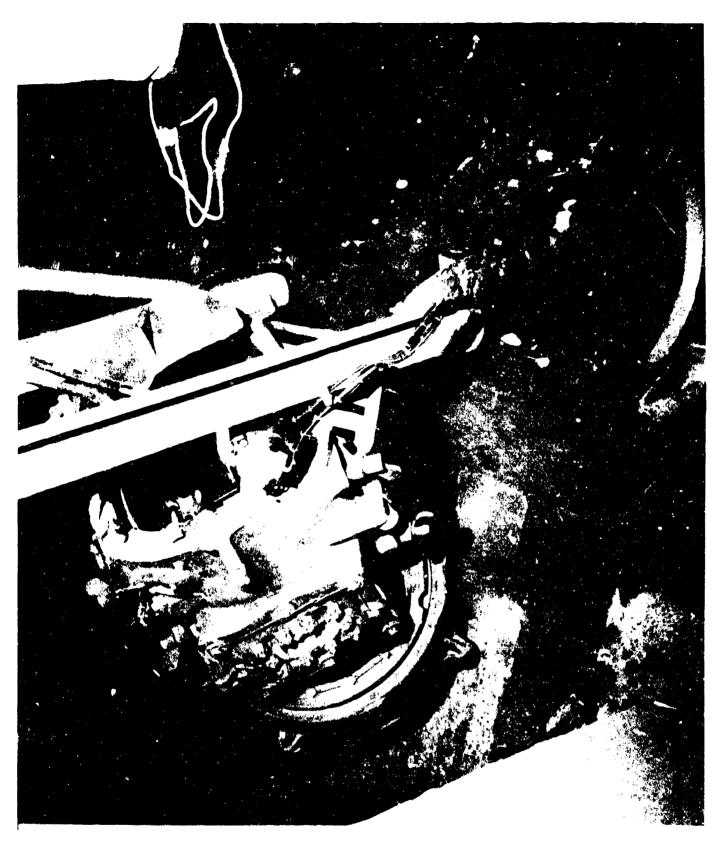
AA-CR-79-1935-11. Looking to starboard and slightly forward on forward AA defense station at broken radar drive unit. Unit has fallen from S.K. radar.

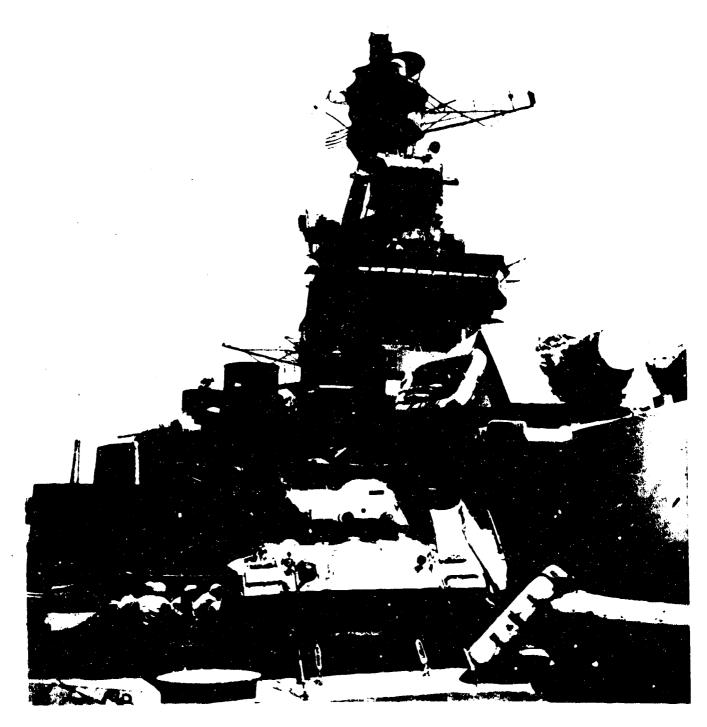
AA-CR-80-1909-10. Looking aft at forward superstructure from starboard side.

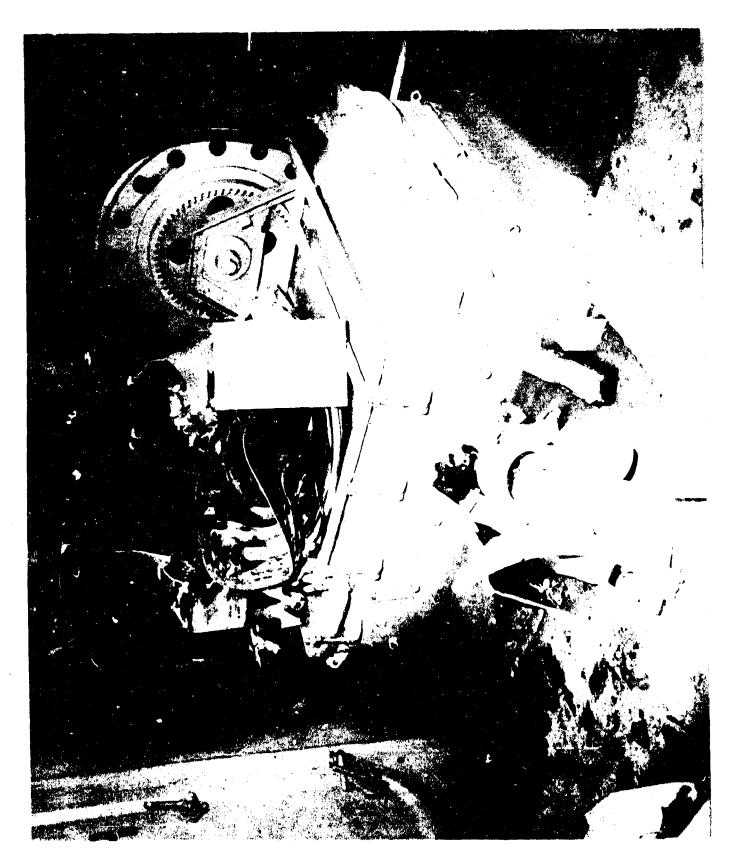
AA-CR-82-1830-9. Starboard 36" searchlight carried from platform and lying on superstructure deck in way of starboard access to upper deck at frame 68.

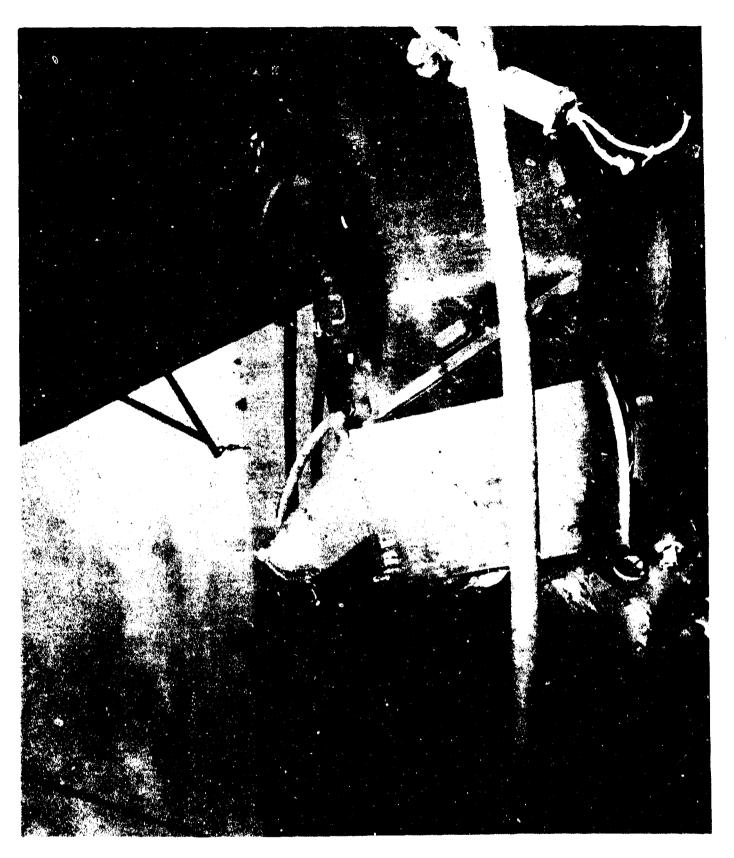
AA-CR-80-1830-6. Looking aft and to starboard on 36" searchlight platform on forward tripod at remains of searchlight. Note broken trunnion arms.

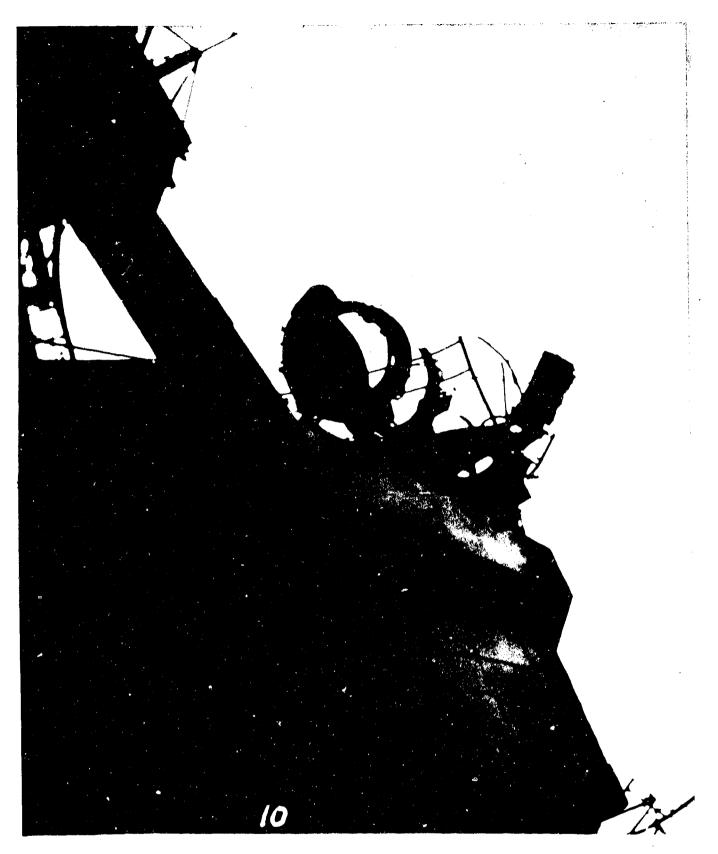
AA-CR-79-1935-10. Looking up, aft, and inboard at wrecked port searchlight or searchlight platform. Forward A.A. defense station in foreground.

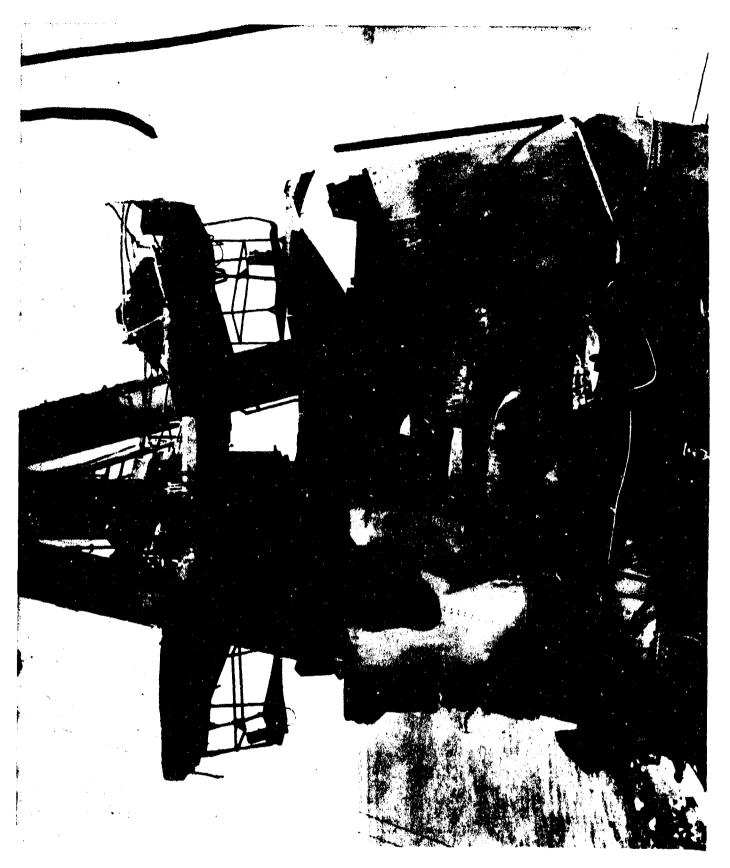
AA-CR-80-1911-6. Foremast structure looking forward from mainmast.

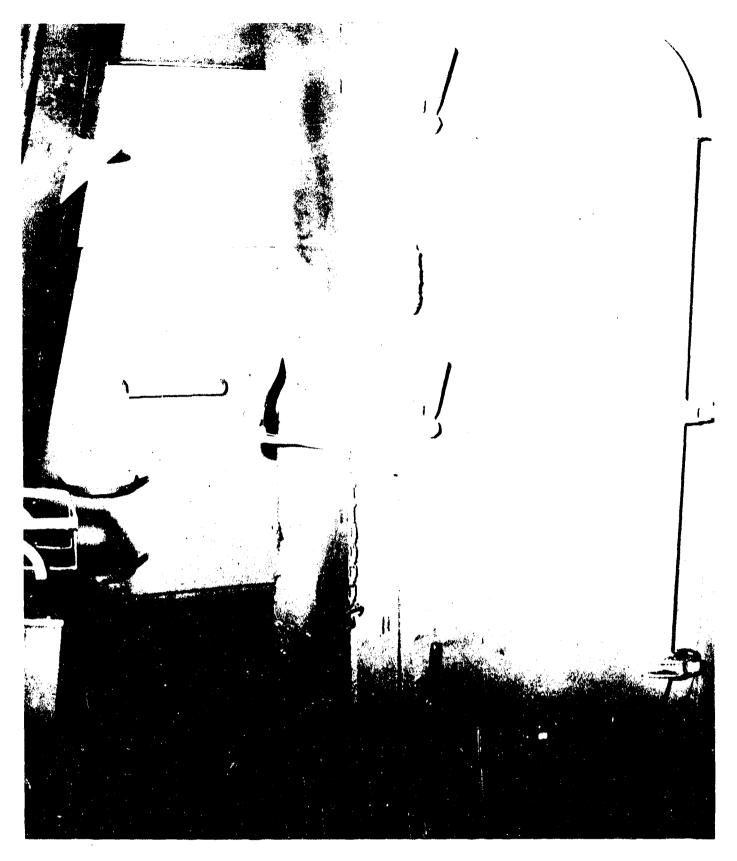
AA-CR-80-1911-11. Main battery and fire control station looking to port at frame 67. Note damaged after bulkhead of bridge urinal.

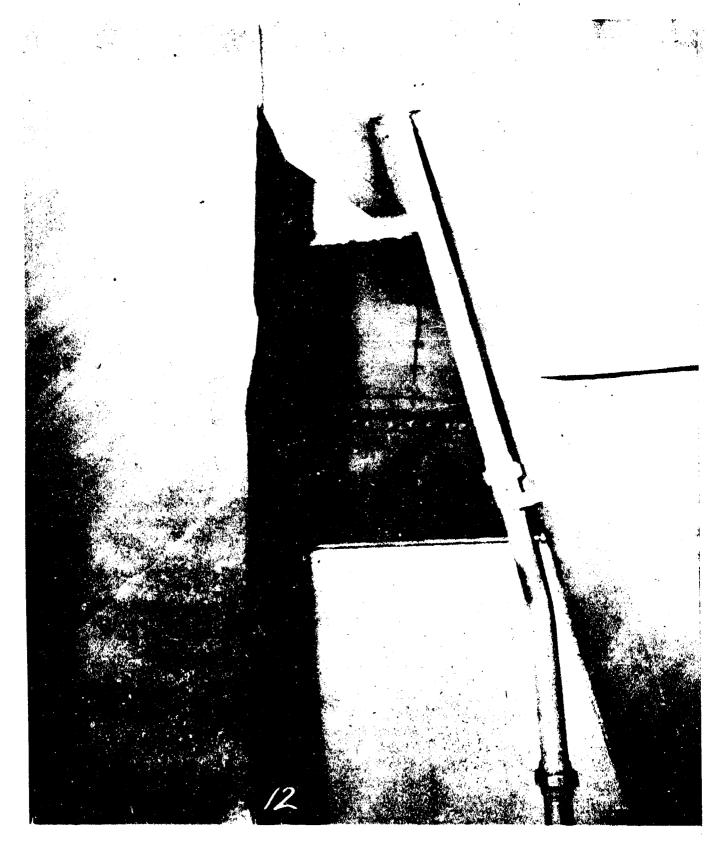
AA-CR-80-1911-12. Main battery and fire control station looking aft at after port corner of bridge urinal from about frame 66. Note stack in background.

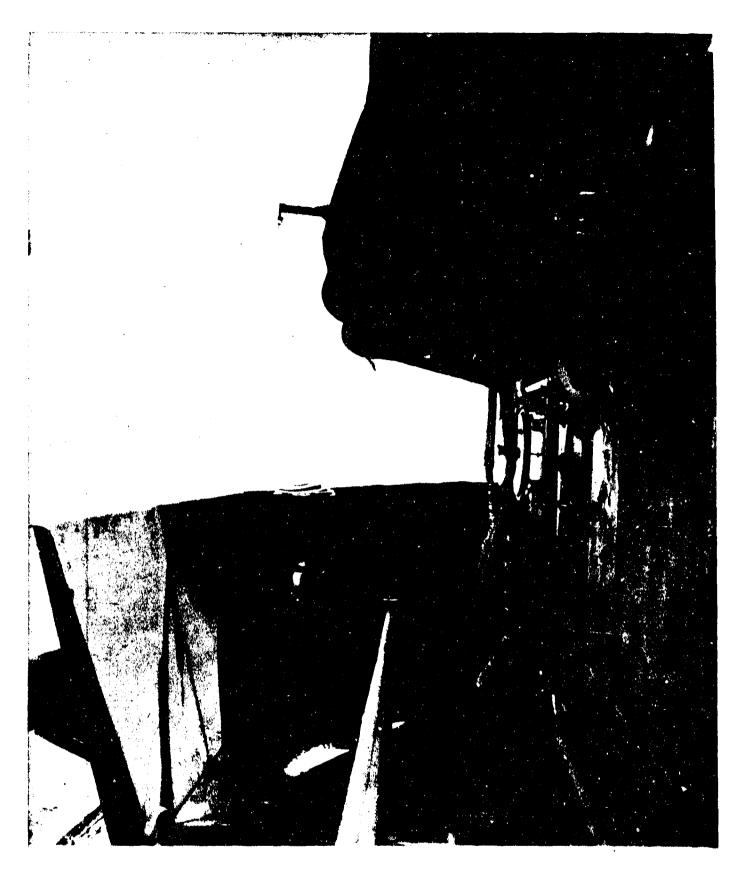
AA-CR-65-1742-7. Looking forward at blast damage to port wing of navigation bridge and underside of open bridge wing.

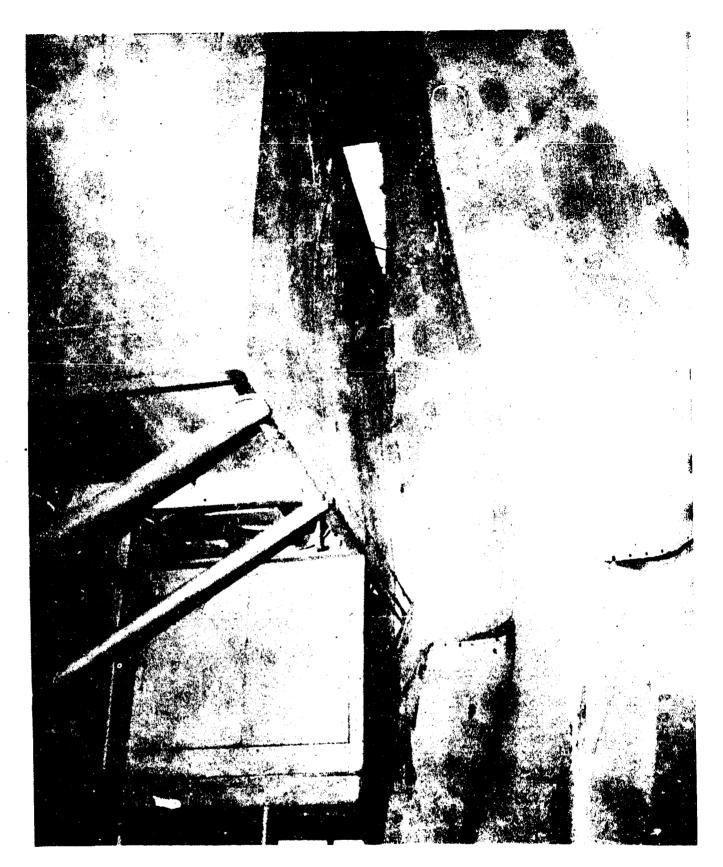
AA-CR-175-2155-2. Superstructure deck at frame 67 looking to starboard at after face of forward superstructure and forward part of stack.

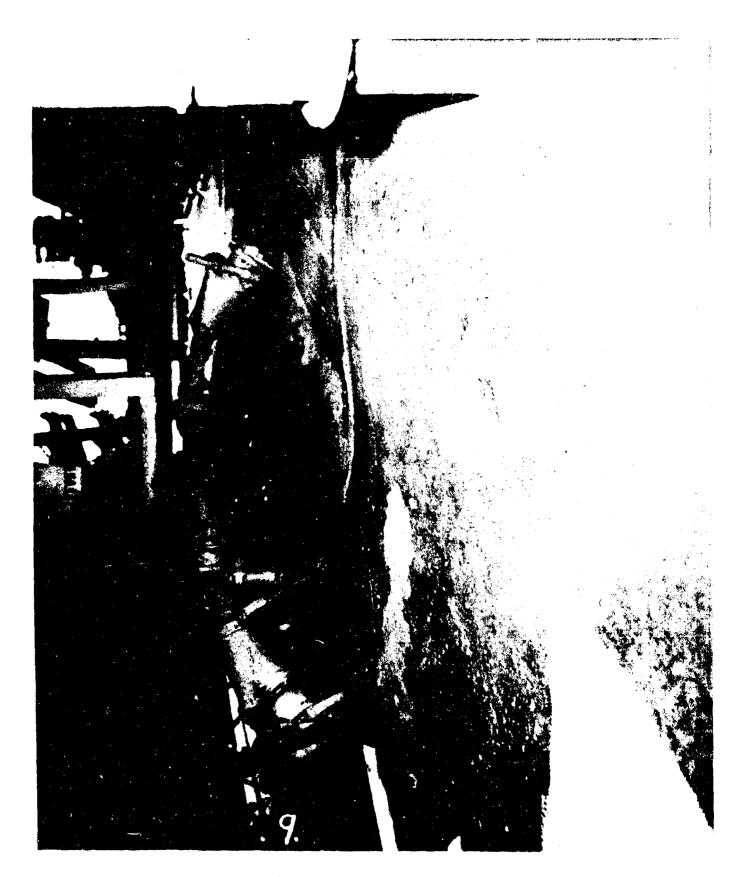
AA-CR-79-1935-9. Superstructure deck deflection at frame 50 under the overhang of turret No.2. Looking to starboard and slightly forward.

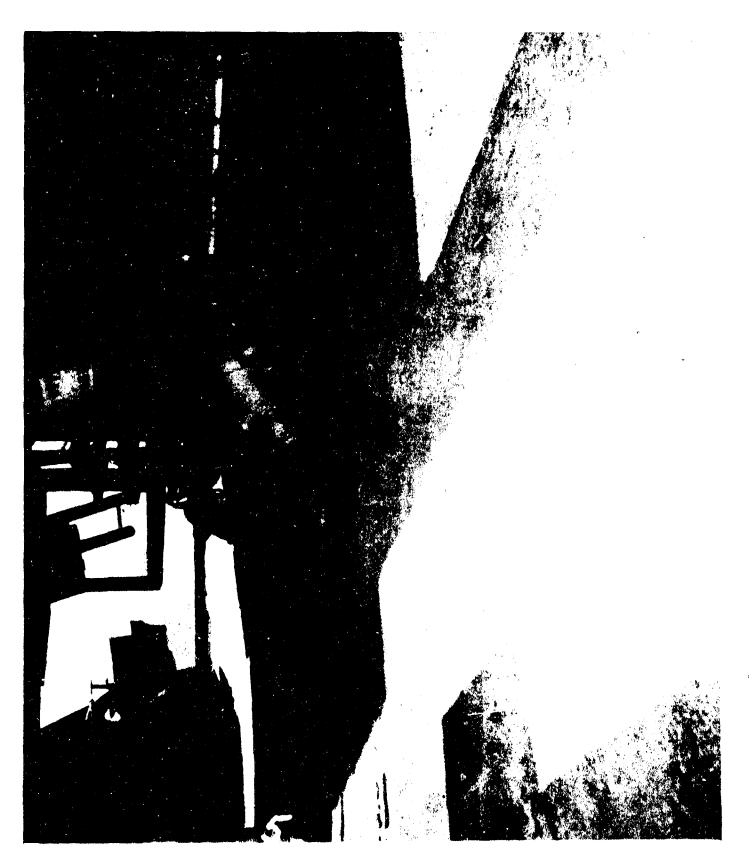
AA-CR-80-1910-5. Superstructure deck, deflection at frame 50 under to overhang of turret No. 2, looking forward and to port.

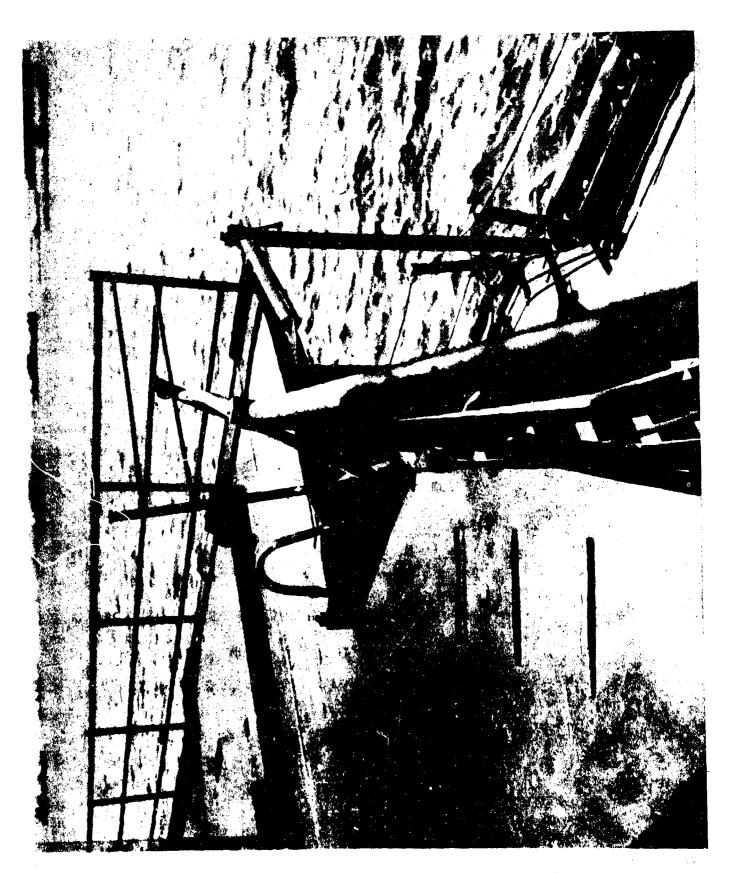
AA-CR-80-1910-7. Superstructure deck looking aft and outboard from frame 58 port. Railings and gutter strips were damaged by ships force removing equipment from fore-top.

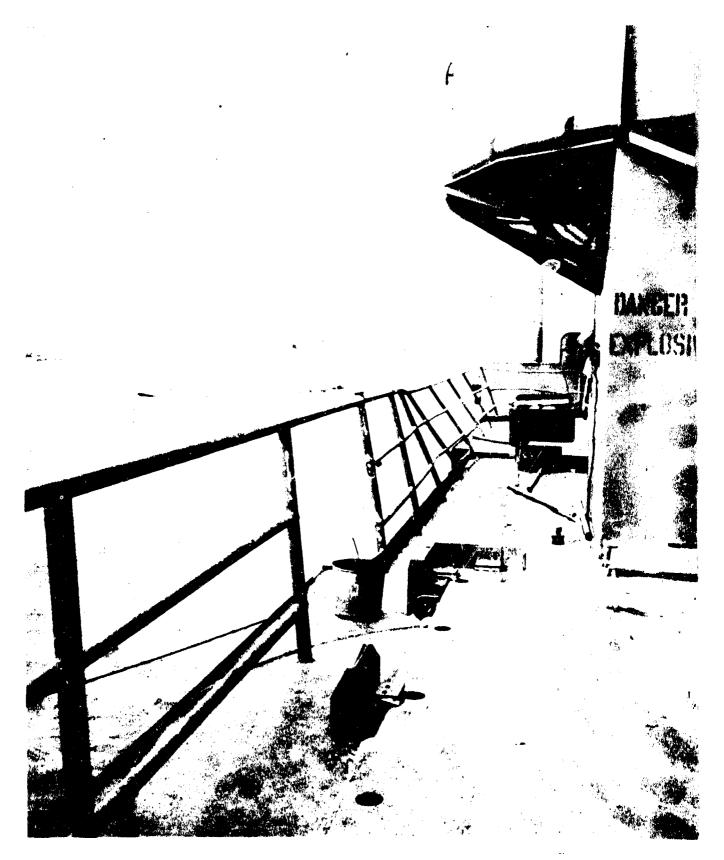
AA-CR-175-2154-11. Looking aft along starboard side of superstructure deck from frame 62 showing damage to the handrail.

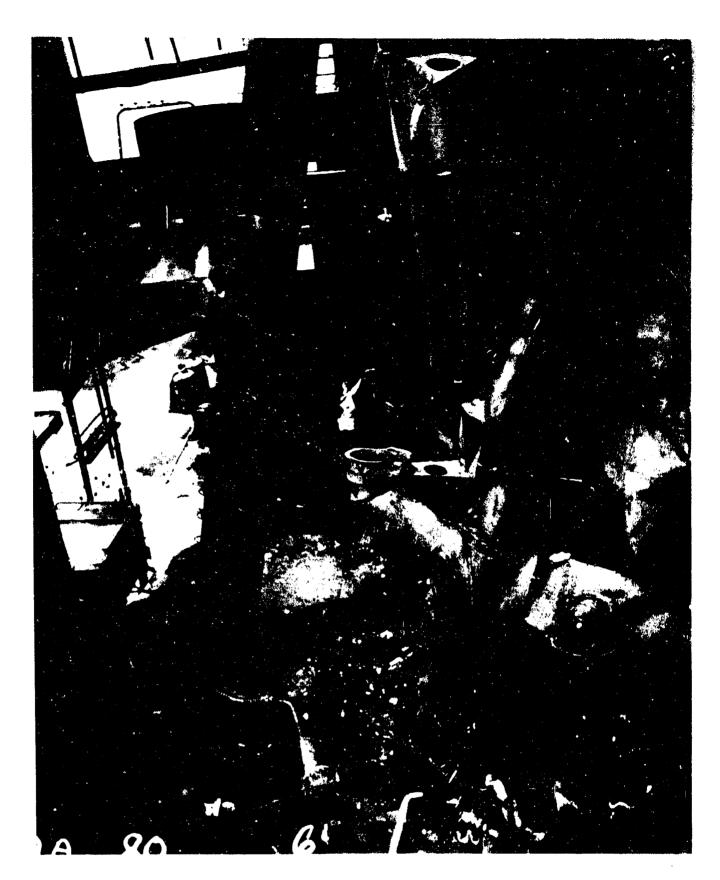
AA-CR-80-1900-6. Lower section of broken Charlie Noble and damaged stack looking forward, down, and to port.

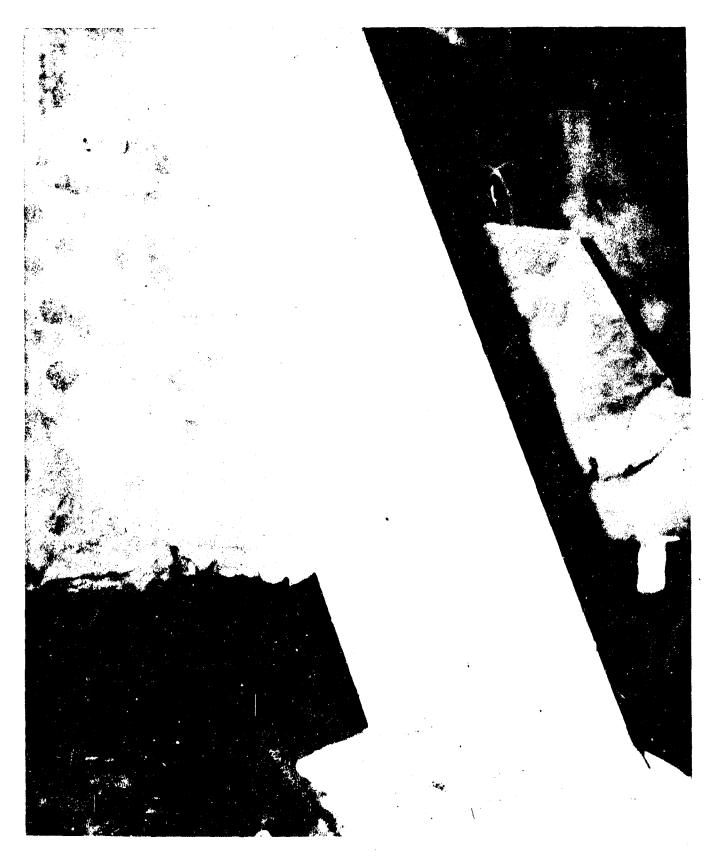
AA-CR-175-2137-8. Outboard after leg of the starboard gun tub at frame 73, on 02 level. Note that deck is pulled up by leg.

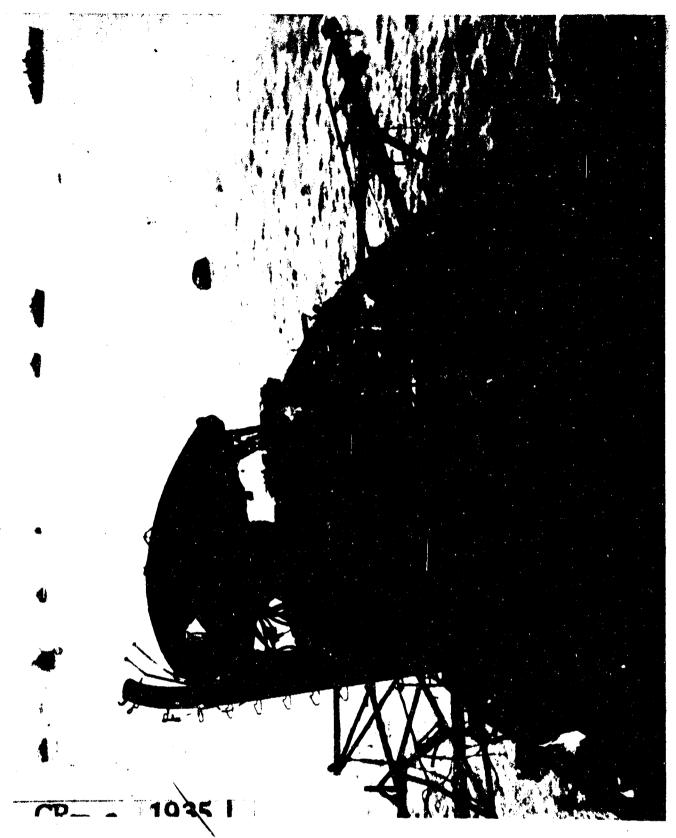
AA-CR-79-1935-12. Topside p otograph looking down and aft from foremast. Lower end of mainmast can be seen still in place. Upper section hanging down, held only by electrical wiring. Note damage to supports of magnesyn compass transmitter mounted on mast.

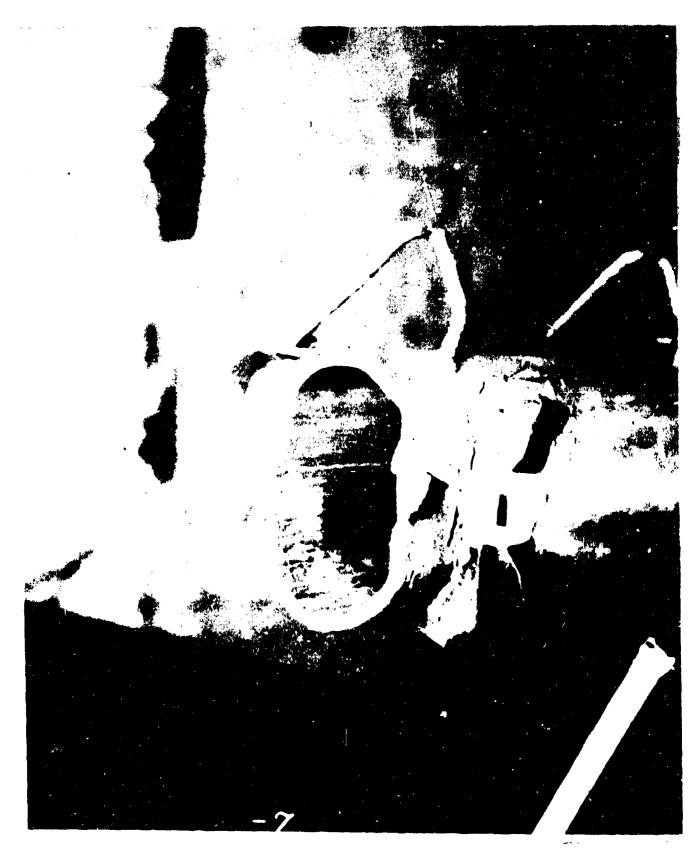
AA-CR-80-1900-7. Break in mainmast pole.

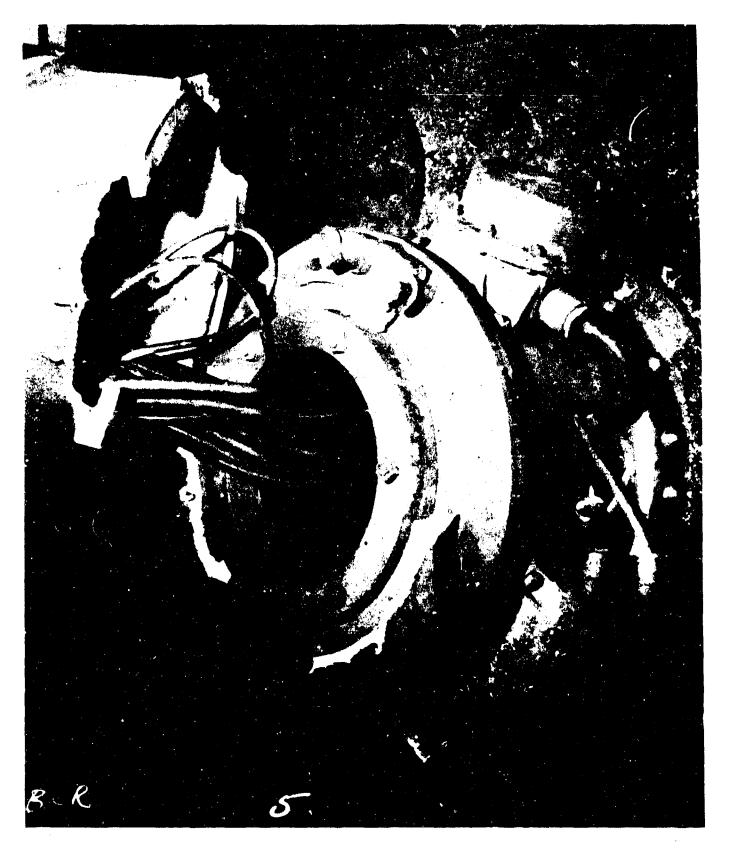
BB-CR-80-1911-5. Main battery director platform on mainmast, frame 80, looking forward showing fractured director pedestal.

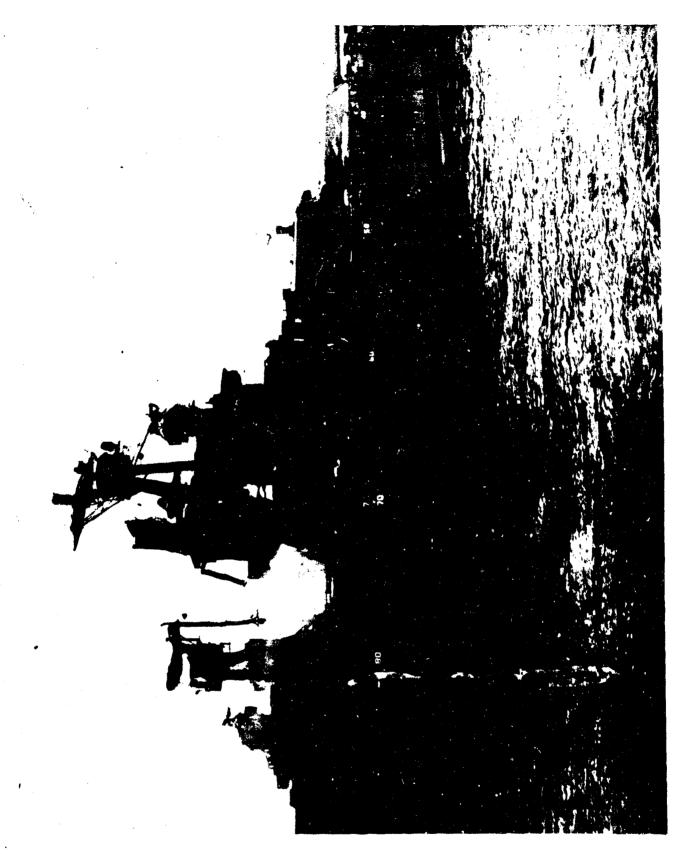
AA-CR-62-1832-9. Surfaces shot from starboard beam. Note smoke from fire on superstructre deck, frame 75.

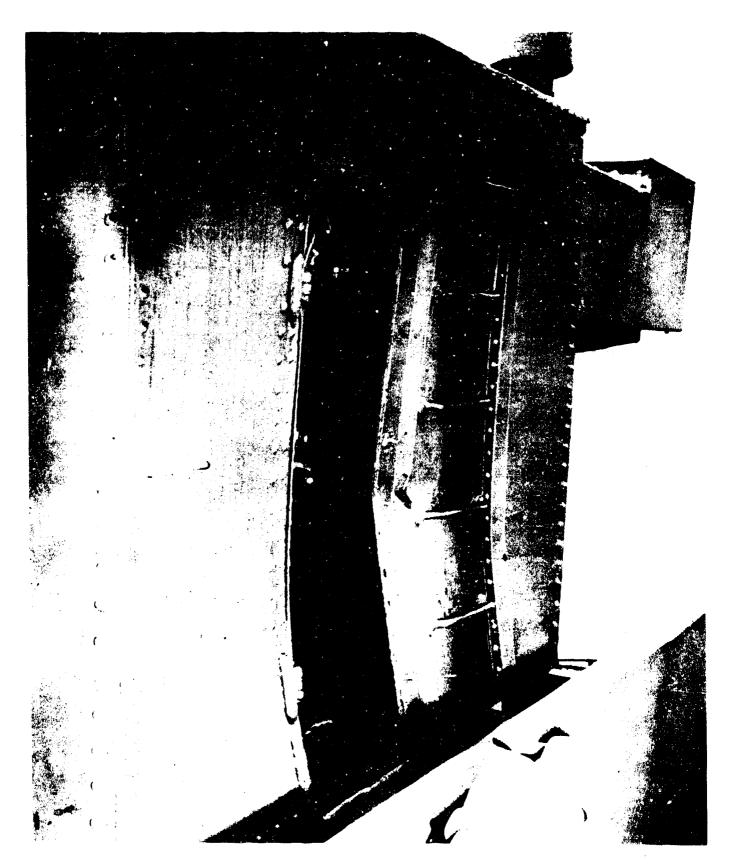
AA-CR-65-1742-6. Blast damage to rear of rangefinder booth, turret No. 2.

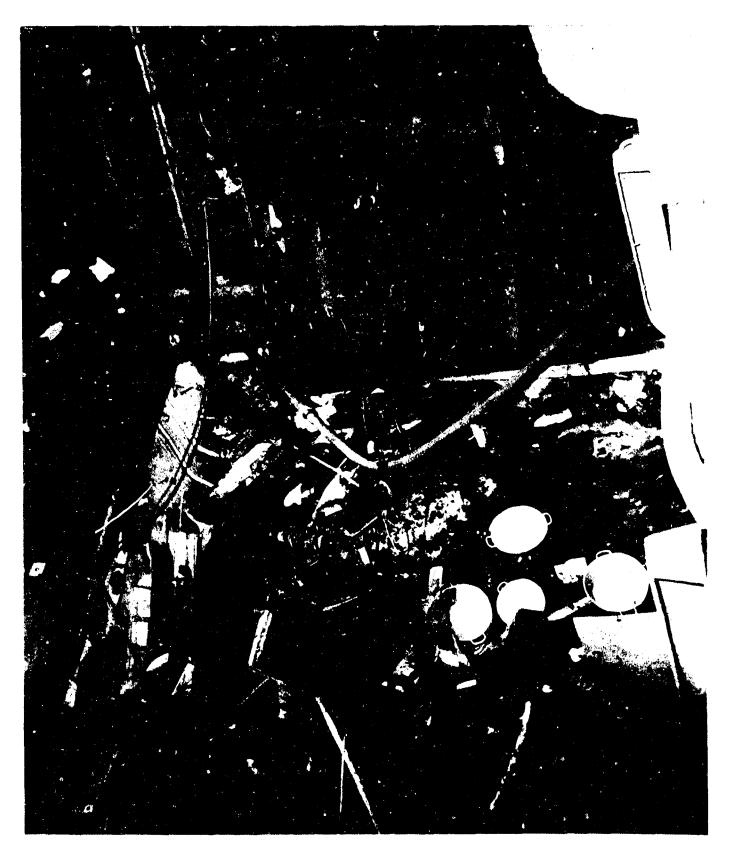
AA-CR-175-2137-7. Looking down and forward at collapsed section in port side of main deck centered at about frame 88.

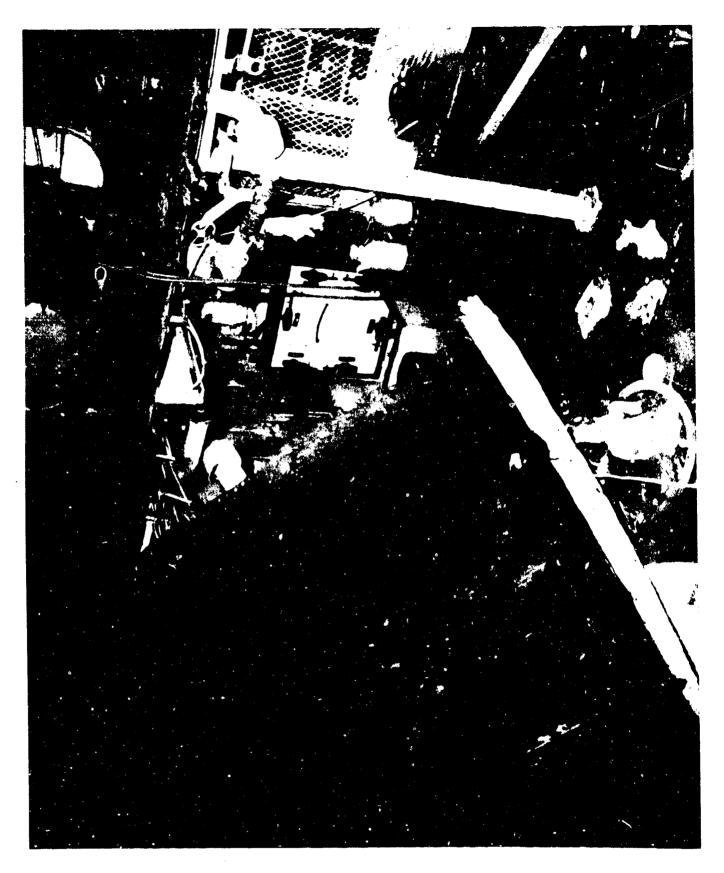
AA-CR-65-1742-10. Caved in deck over machinery access opening, main deck, looking forward from port. The tear has progressed beyond the forward edge of the hatch, frame 88 to about frame 86.

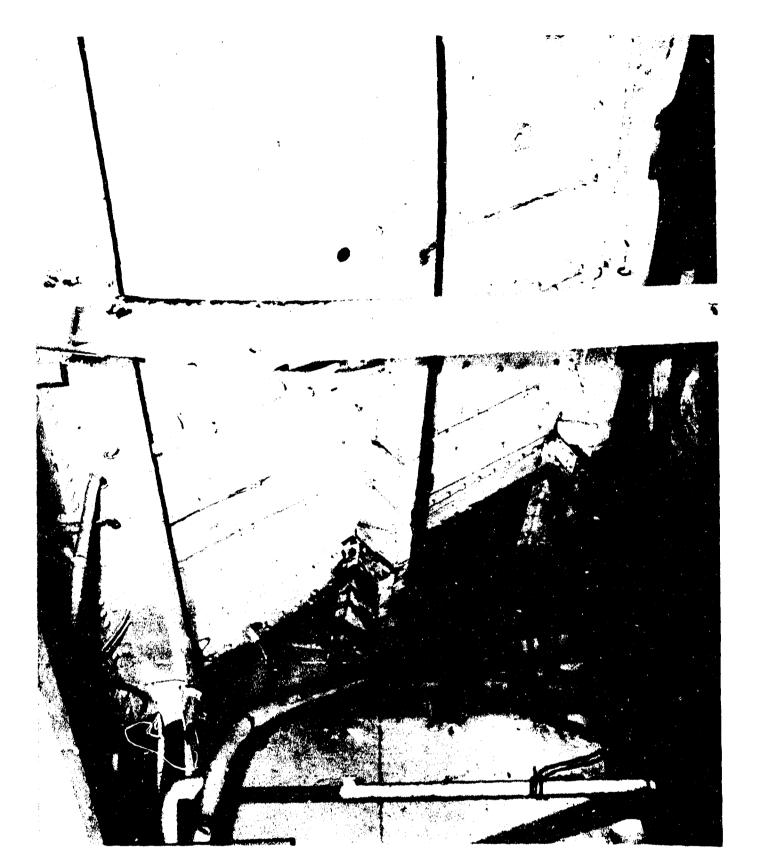
AA-CR-175-2136-11. Compartment C-291-1L. Looking forward and to port on second deck at after portion of collapsed main deck (port side of frame 86-91). Note buckled stanchion at frame 91.

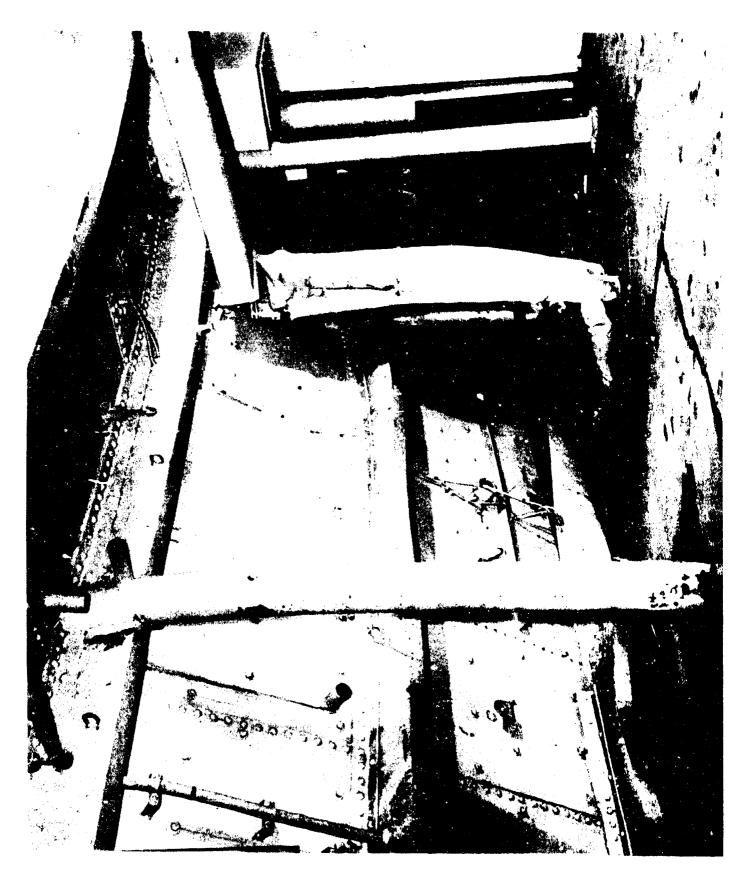
AA-CR-175-2136-10. Compartment C-291-1L. Looking forward and to starboard on second deck at after portion of collapsed main deck (port side of frames 86-91). Note buckled stanchion at frame 91.

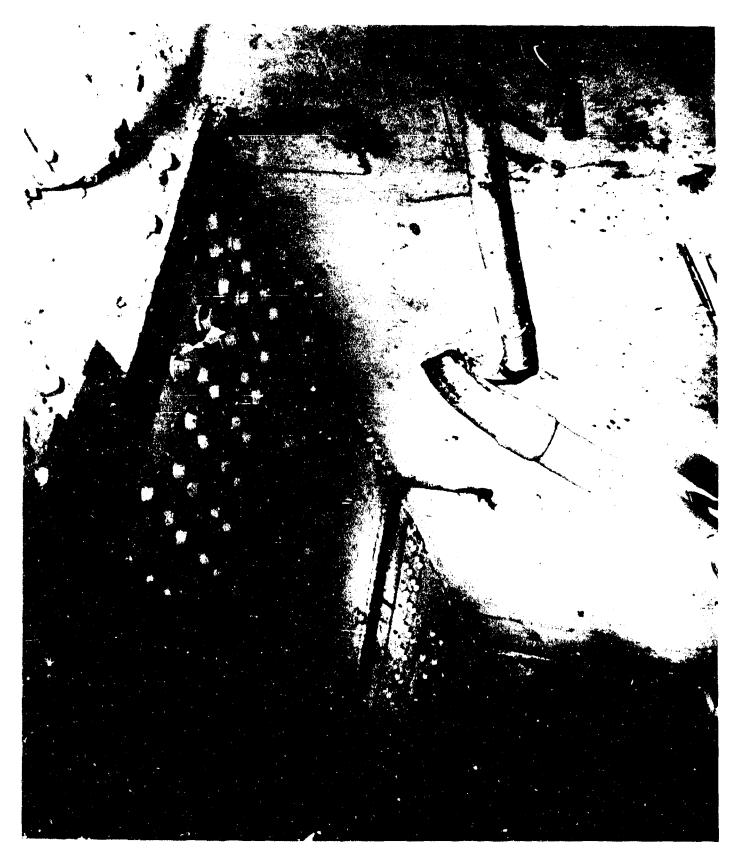
AA-CR-175-2137-4. Compartment C-291-1L. Looking aft and outboard at outboard edge of main deck failure (collapsed section, port side, frames 86-91.) Note transverse beam and failures at longitudinal bulkhead.

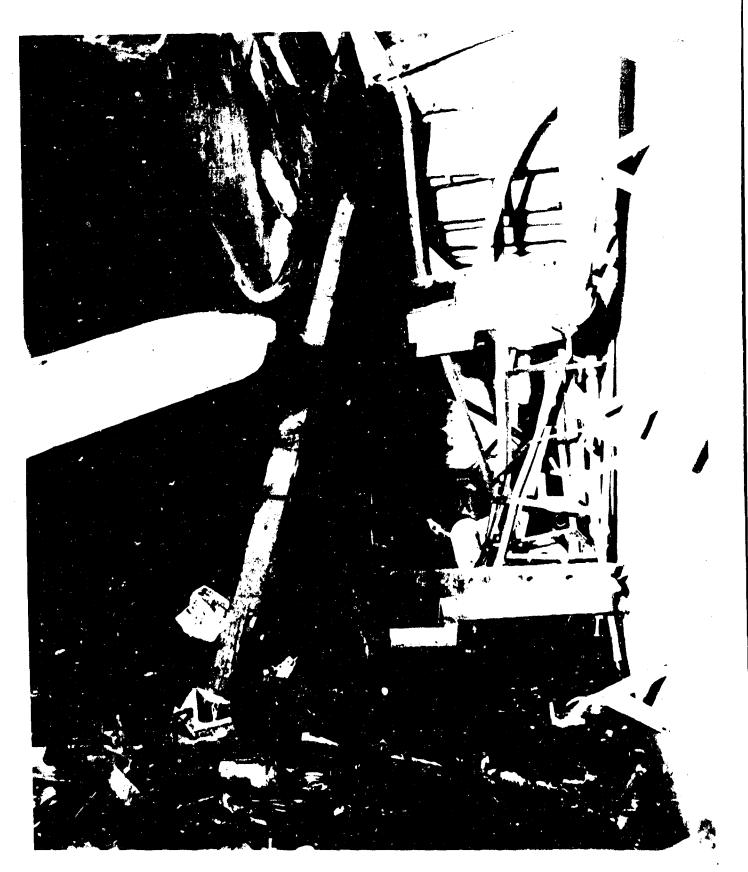
AA-CR-175-2137-3. Compartment C-291-1L. Looking aft from second deck at outboard edge of main deck failure. Collapsed area is on port side, frames 86-91.

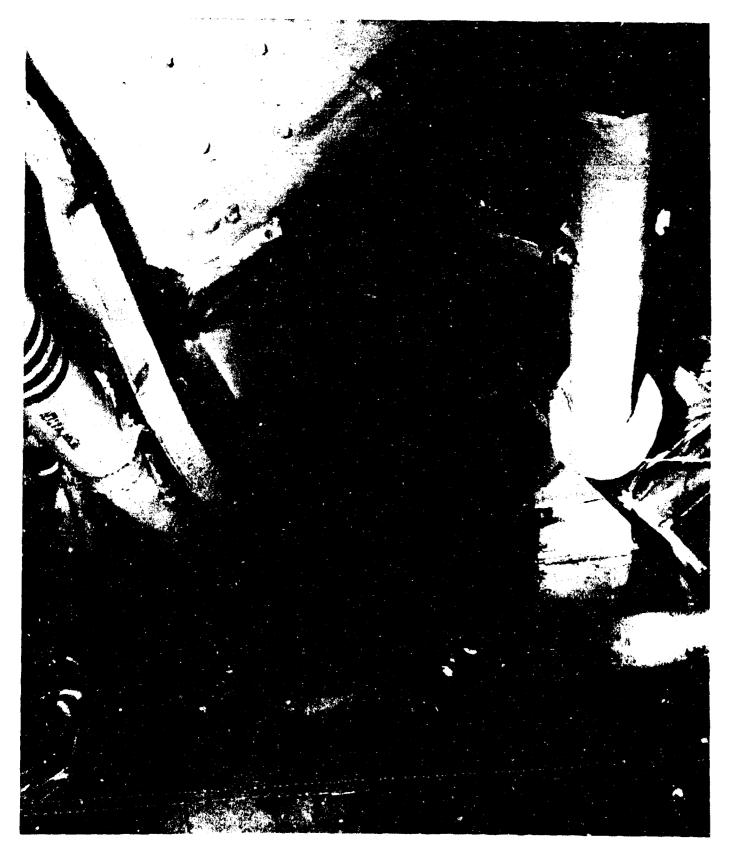
AA-CR-175-2137-5. Crew's berthing, C-291-1L, second deck, looking inboard along frame 86 at forward extremities of collapsed section on main deck, port side, frame 86-91.

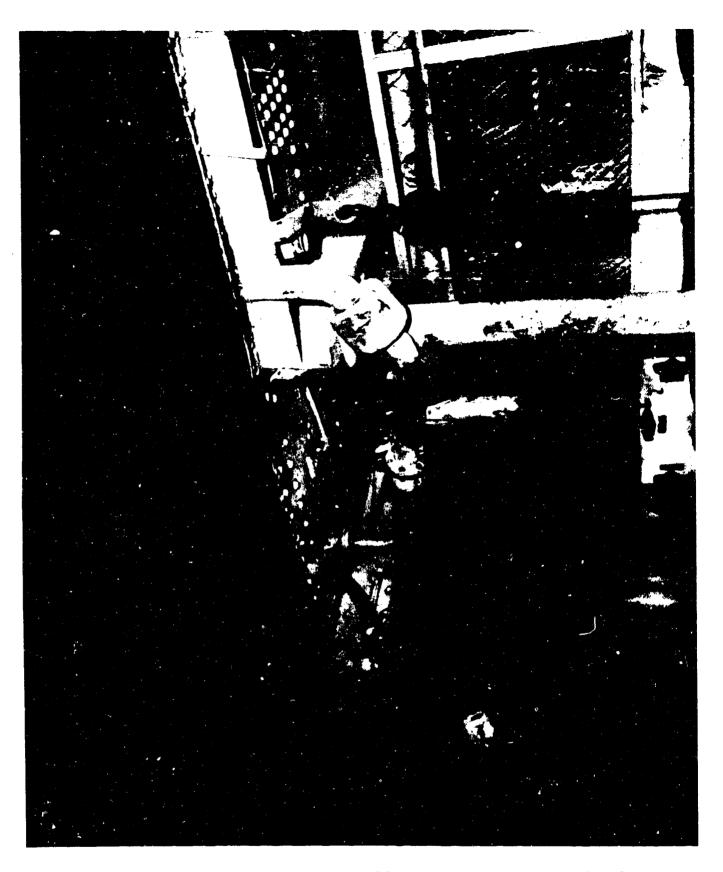
AA-CR-175-2137-2. Compartment C-291-1L. Looking forward and to starboard from the second deck at inboard line of failure of main deck beams and deck plating. Collapsed area is on port side, frames 86-91.

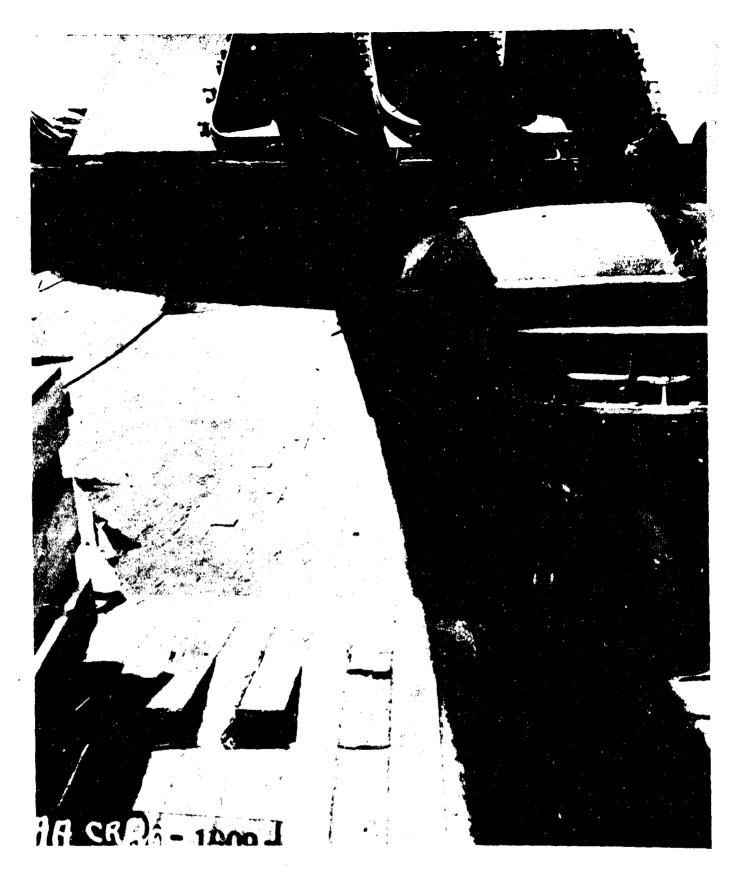
AA-CR-80-1909-6. Looking forward along the centerline of the main deck from frame 127. Note deck deflection forward from bulkhead 122. (below deck) Turret No. 4 is in background.

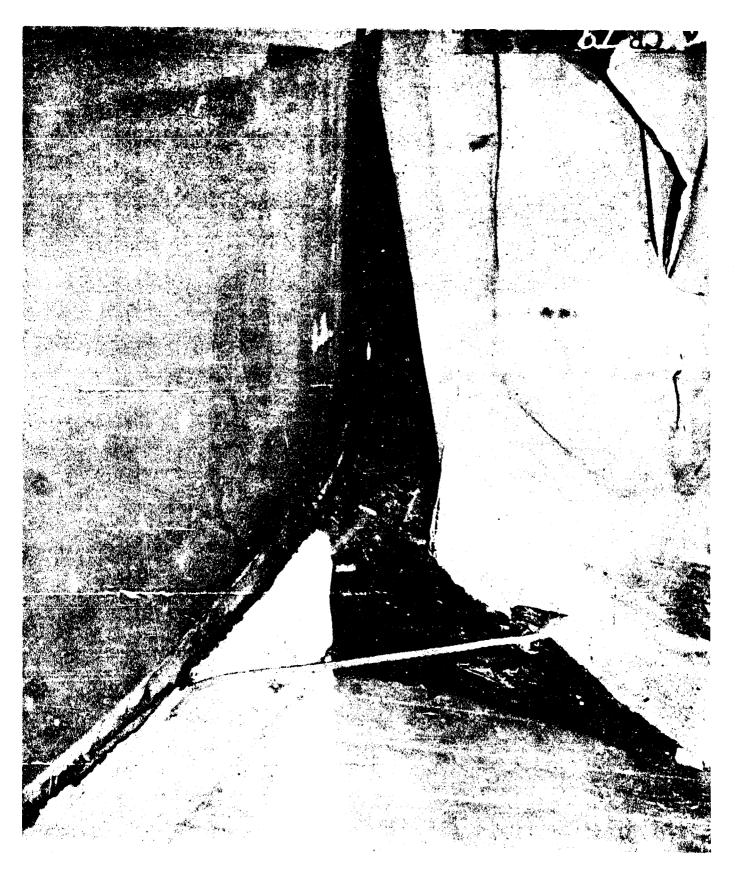
AA-CR-79-1935-5. Looking to starboard on main deck at after side of turret No. 4. Note deck pulled away from barbette, frame 116 1/2.
